## **SPECIAL AIRWORTHINESS INFORMATION BULLETIN**

**SAIB:** AIR-22-15

**SUBJ:** Bonded Structure Inspection

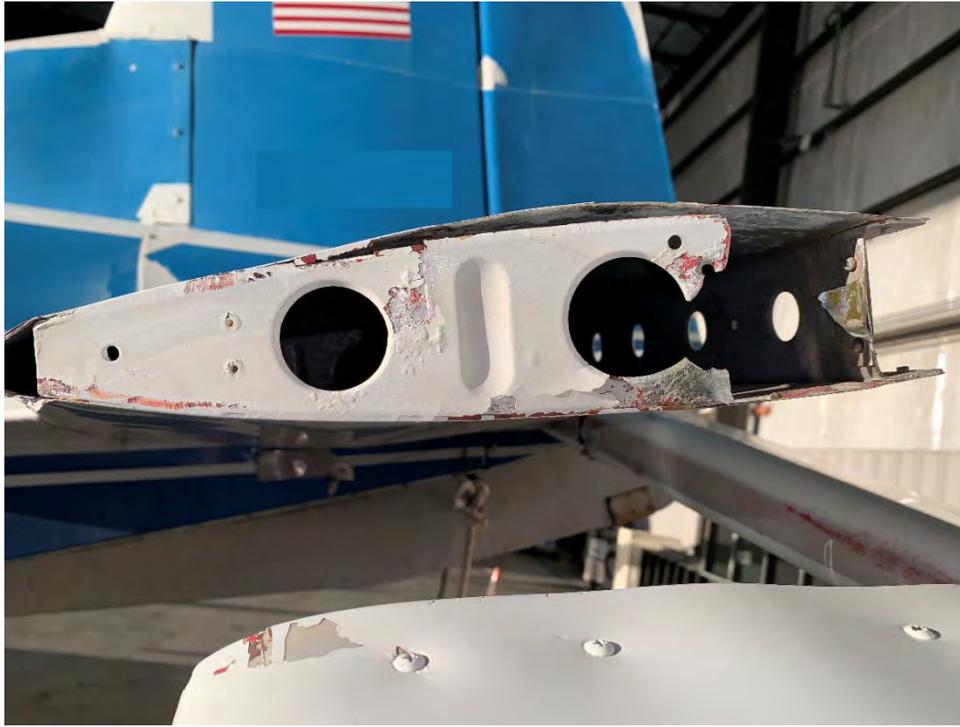
Following an accident involving a True Flight Model AA-5 airplane in January 2021, the FAA issued AD 2021-14-12 on July 12, 2021, which applies to Model AA-1, AA-1A, AA-1B, AA-1C, and AA-5 airplanes. AD 2021-14-12 requires a one-time inspection for bondline corrosion and delamination of the horizontal stabilizer, including the attachment point of the elevator. The accident airplane's elevator partially separated from its attachment to the horizontal stabilizer, which resulted in flutter of the elevator and near loss of pitch control. This airplane was later found to have severe bondline corrosion and delamination in certain areas, including the outboard rib of the horizontal stabilizer and the trailing edges of the elevator trim tabs. The damage can readily be seen in Figure 1, below.

Figure 1. Severely Damaged Horizontal Stabilizer with Skin Delamination and Indications of Bondline Corrosion, Model AA-5

The FAA recommends that the actions outlined in the affected airplanes’ maintenance manual, as well as SB-195A, be followed at the earliest opportunity and at the annual or 100-hour inspections.
