Elevator Failure, 1972 Grumman Traveler

As many of you are aware, a 1972 AA5's elevator attachment system failed in flight. While there is significant damage to the aircraft, neither occupant is known to have suffered any injury. I would consider elevator detachment a "fail fatal" failure mode, so the two individuals are very lucky.

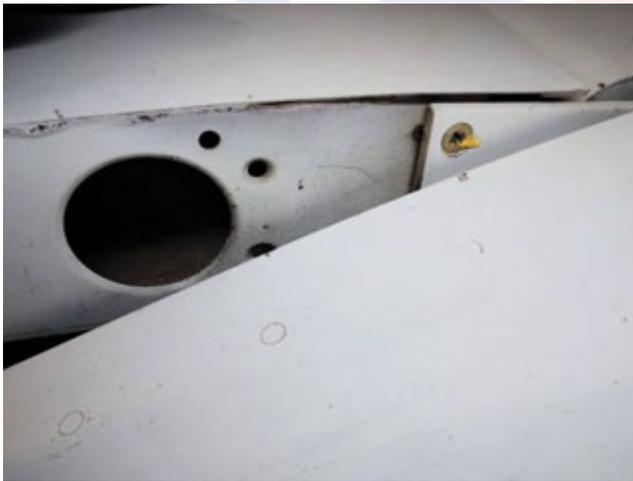
Photo: Traveler hinge.jpg

Photo caption: AA5 Elevator Outboard Hinge

On both the Traveler and Cheetah/Tiger, the hinge and elevator attachment can be viewed with a flashlight from above and below with a flashlight and mirror. Check screws for security & check structure for cracks and/or corrosion.

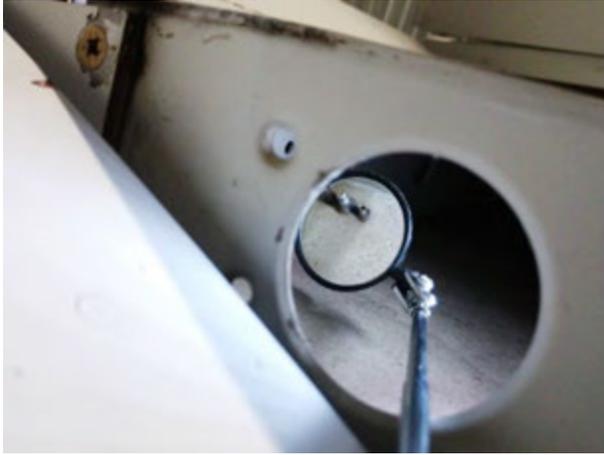
Photo: Traveler nutplate.jpg

Photo caption: AA5 Nutplate Inspection with Mirror

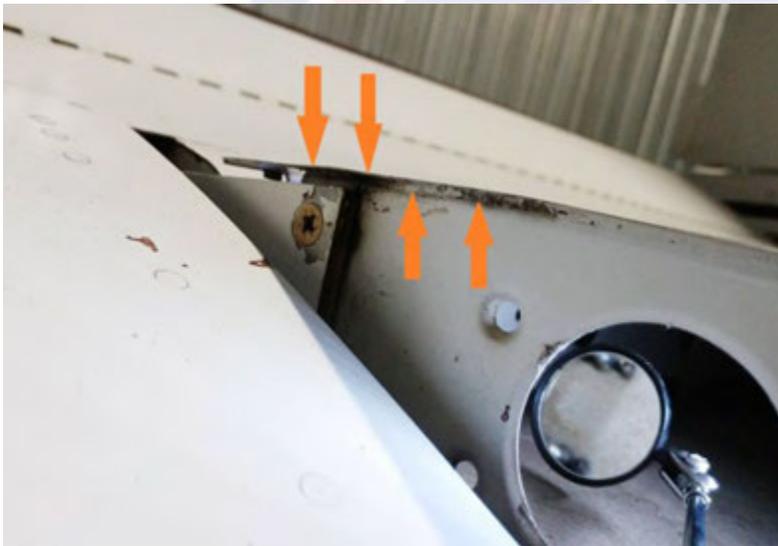
Photo: Check for delamination.jpg

Photo caption: Check for delamination above & below rib.

Also check for delamination of the top and bottom skin from the rib, above and below the hinge attachment.

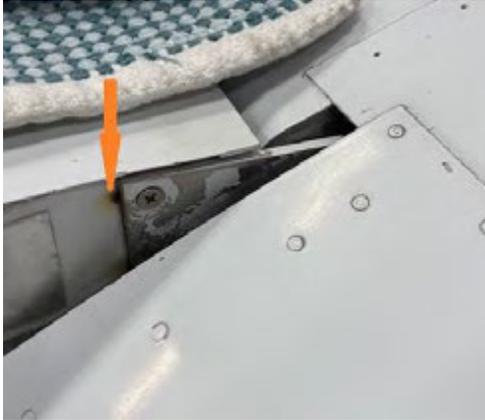
Photo: AA5 Nutplate Corrosion.jpeg

This Traveler's hinge nutplates have minor corrosion presenting on the rib, forward of the hinge, around the nutplate rivets.

Photo caption: AA5 Nutplate beginning corrosion.

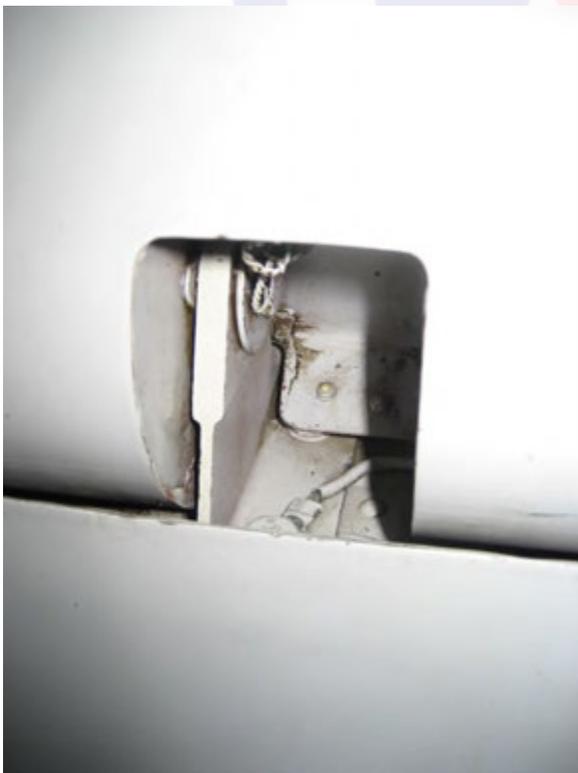
Photo: AA5A Hinge.jpeg

Photo caption: AA5A Elevator Hinge

The hinges of the Cheetah and Tiger are best inspected with a mirror and flashlight from below. Use a soft rag to hold the elevator in the full up position, or pull back & secure the yoke to the seats.

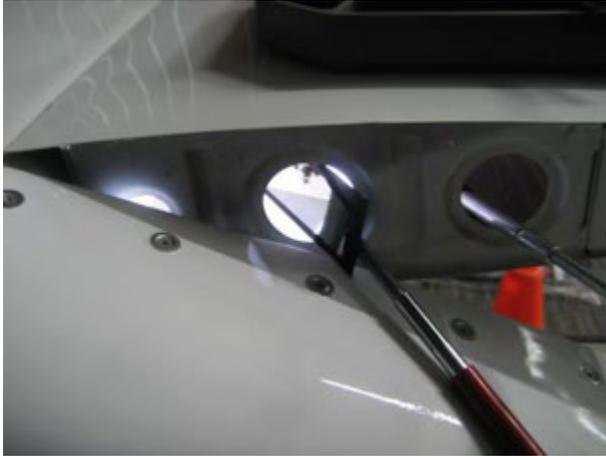
Photo: AA5A Mirror.jpeg

Photo caption: AA5A Inspecting Bolts & Nutplates with Mirror.

A narrow flashlight and mirror allow inspection of the attaching bolts and nutplates, and the interior of the trailing edge of the Cheetah and Tiger's outer hinge. The mid-span interior can only be inspected with a long flexible shaft borescope.

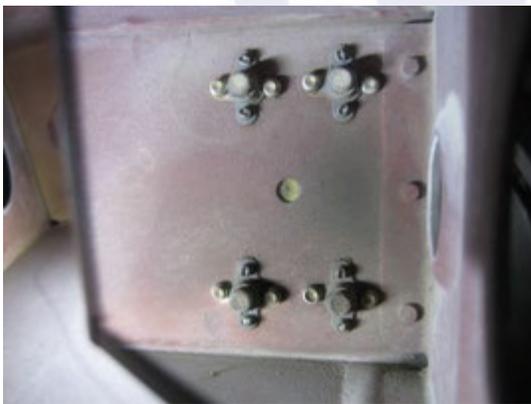
Photo: AA5A Nutplates.jpg

Photo caption: AA5A Outboard Hinge Inside Rib View of Nutplates in Mirror
