AA5 Elevator Failure

by: John Cotter, A&P, IA, Technical Director

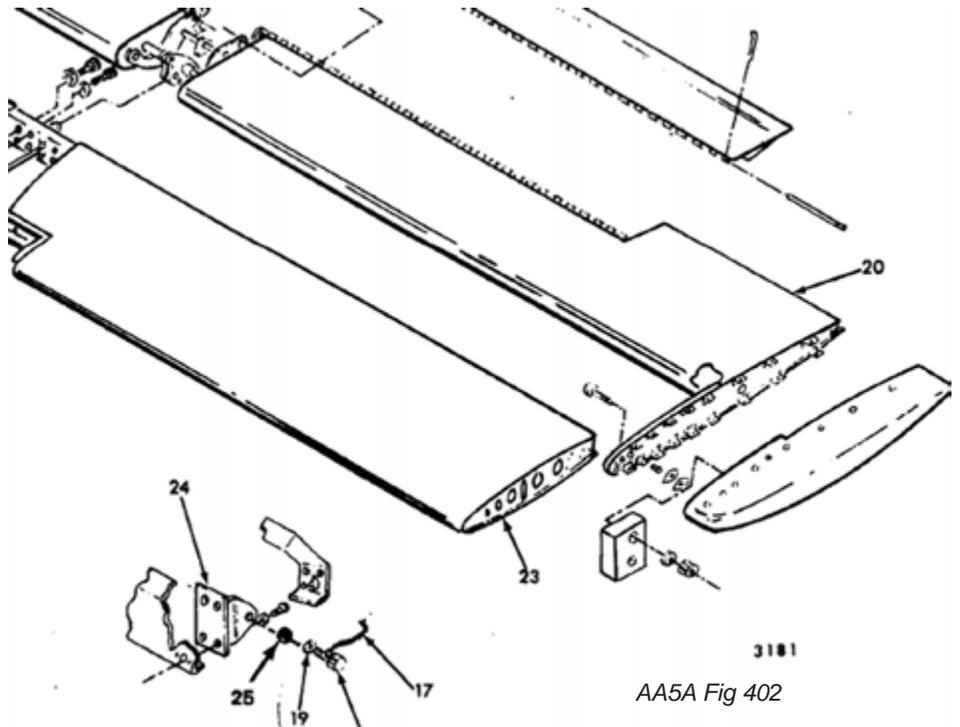
AA5A Fig 402

The Cheetah and Tiger's elevators each rotate on two bolts in two hinges, one located mid-span and one located at the outboard end. The mid-span and outboard hinges (item 24 in Fig. 402) are secured to the trailing edge of the horizontal stabilizer by four bolts. Illustration Fig. 402 only shows one of the hinges, in the detail view at the bottom of this illustration.

The hinges of the Cheetah and Tiger are best inspected with a mirror and flashlight from below. Use a soft rag to hold the elevator in the full up position.

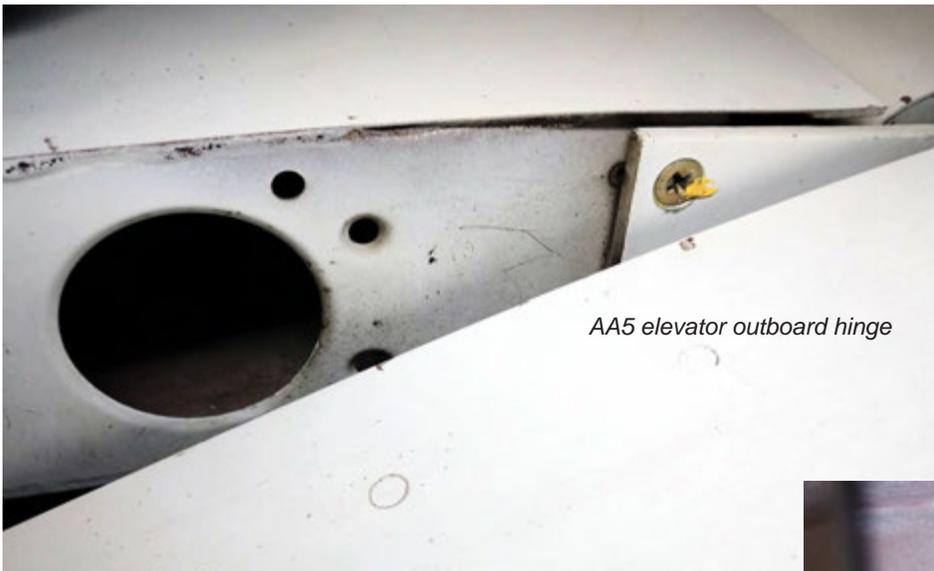
AA5 elevator outboard hinge

There are also differences in the method of attaching the elevators to the horizontal stabilizers. Each of the Traveler's elevators is secured by the bolt through the bellcrank and the end of the torque tube which pivots in a single outboard hinge with nylon bearing insert. This hinge is attached on the outside rear of the outboard rib of the horizontal stabilizer, by two screws (AA-5, Fig. 401, items 17, 16 and 18.) It is the area of this outermost rib, to which this hinge attaches, and is missing in the Traveler photo to the left.

On both the Traveler and Cheetah/Tiger, the hinge and elevator attachment can be viewed with a flashlight and mirror from above and below with the mirror, or by sitting on the ground. Check screws for security and check structure for cracks and/or corrosion.

Also check for delamination of the top and bottom skin from the rib, above and below the hinge attachment.

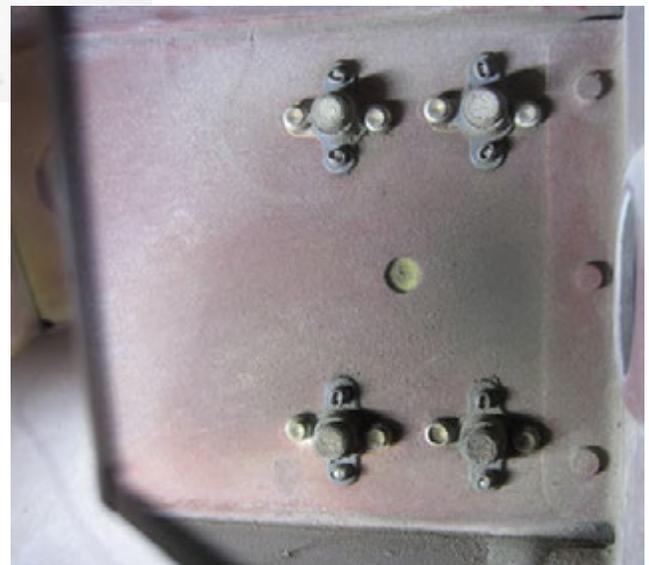
AA5A outboard hinge
inside rib view of
nutplates in mirror.

inspection of the attaching bolts and nutplates, and the interior of the trailing edge of the Cheetah and Tiger's outer hinge. The mid-span interior can only be inspected with a long flexible shaft borescope.

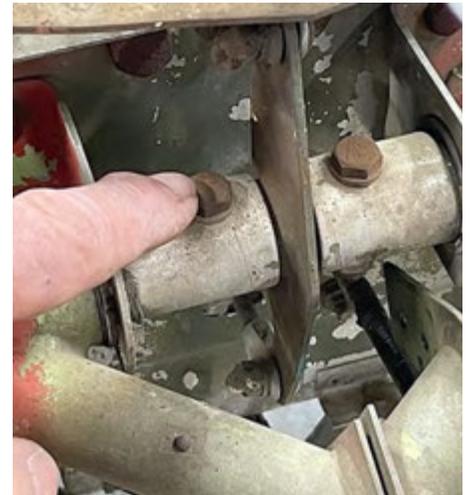
AA5 elevator torque tubes and bellcrank assembly.

Removing the upper half of the tail cone will allow inspection of the torque tubes, bellcrank, bolts, and elevator trim system. It takes about 10 minutes to remove the fairing and 10 minutes to reinstall it. It requires a Phillips screwdriver. Steps: Trim control full aft (nose up.) Remove screws. Trim control full forward (nose down.) Remove upper fairing, being careful not to scratch the paint. Inspect. Reinstall upper fairing. Reinstall all screws loosely. All installed? Lightly torque all screws. Trim control back to neutral.

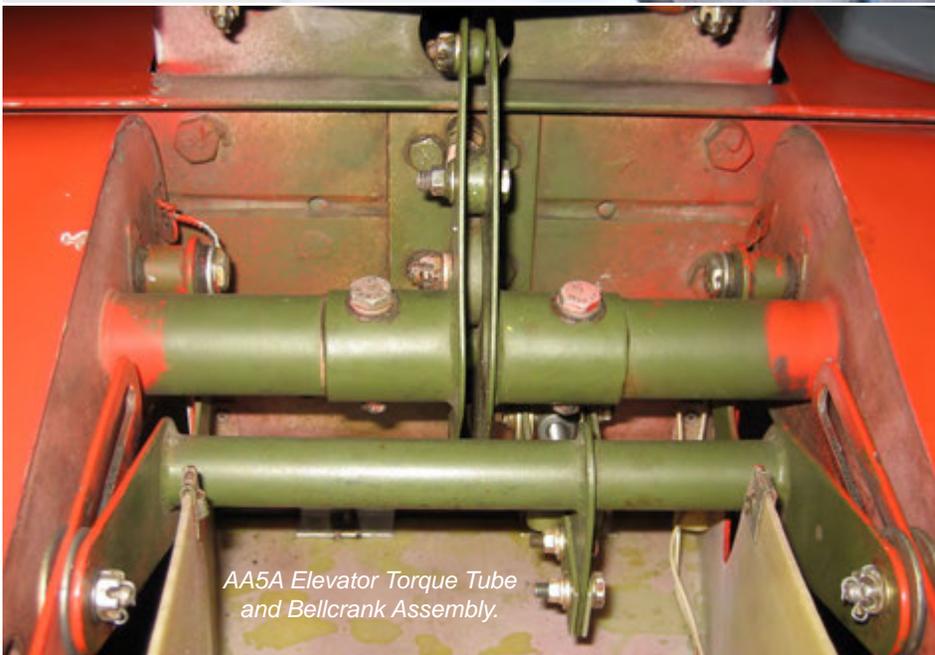
AA5A Elevator Torque Tube and Bellcrank Assembly.

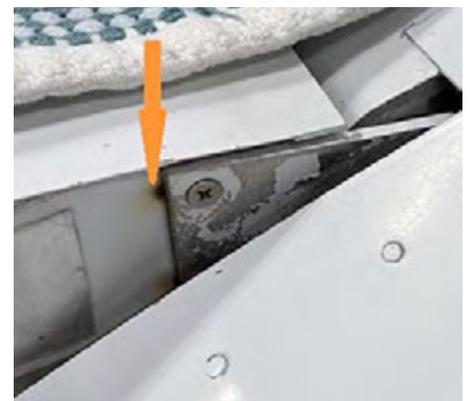
This Traveler's hinge nutplates have minor corrosion presenting on the rib, forward of the hinge, around the nutplate rivets.
