SUBJECT: Potential decreased service life of Slick 4-cylinder magneto distributor gear assemblies. **Based on process and component improvements following the initial release of this service bulletin, the serial number range is being extended in this revision. Magnetos previously returned for compliance to SB1-15 must be returned or inspected for compliance to this revision SB1-15A.**

AFFECTED: The following 4-cylinder magnetos with serial numbers between **08090001 thru 16071072**, K3822 distributor block replacement kits, and K3008 distributor gear assemblies dated **September 26, 2008 thru September 1, 2016:**

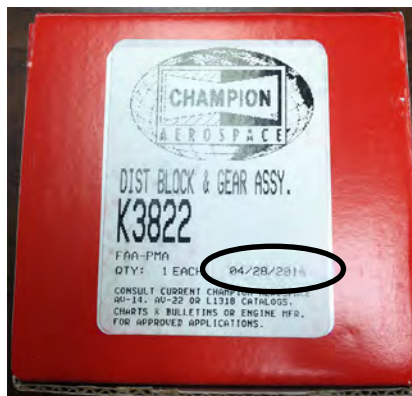
Figure 1. Replacement Kit Box Label Date Code

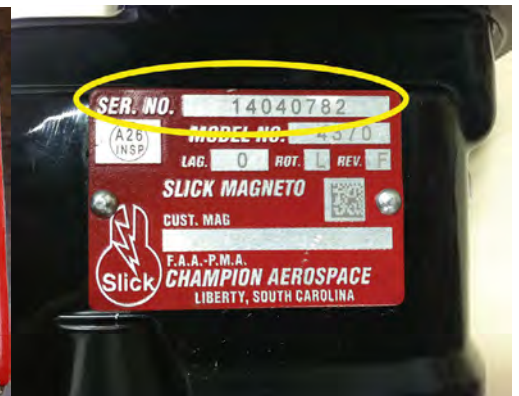
Figure 2. Magneto ID Label Date Code

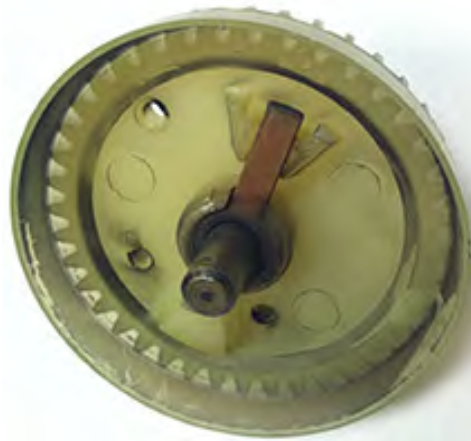
The initial release of SB1-15 was based on a limited number of field reports and product returns, Champion Aerospace has identified a possible condition in the distributor gear assemblies of 4-cylinder magnetos that can lead to decreased service life. Some of the returned products contained distributor gears exhibiting loosening of the electrode finger. This condition was observed in magnetos with a varying number of service hours. Typical symptoms are unusual RPM drop during magneto check, difficulty starting, and/or rough running engines.

Figure 3. Affected K3008 Distributor Gear With Copper Electrode

If it is not possible to confirm the version of the distributor gear that is installed in a given magneto from maintenance records, the magneto may be removed from the engine in order to have the housing and distributor block removed to allow visual inspection of the distributor gear. Distributor gears with Copper electrodes must be replaced with distributor gears with Monel electrodes.

COMPLIANCE: REMOVE affected distributor gear assembly in subject magnetos and REPLACE with replacement distributor gear assembly, K3008, as soon as possible, not to exceed the next 50 hours. Document Service Bulletin compliance as written entry in applicable Aircraft and/or Engine logbook.

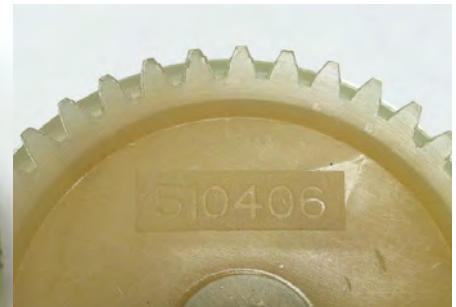
Figure 4. K3008 Distributor Gear Marked 510406 (Backside)

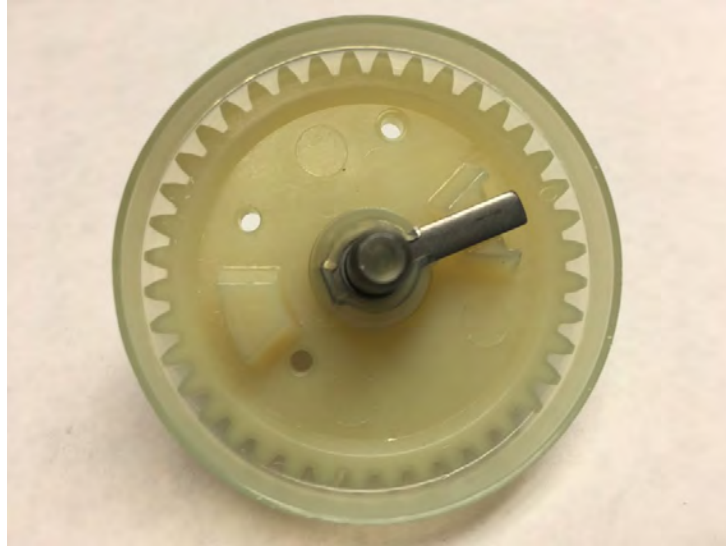
Figure 5. K3008 Distributor Gear With Monel Electrode
