Elevator Failure, 1972 Grumman Traveler

As many of you are aware, a 1972 AA5's elevator attachment system failed in flight. While there is significant damage to the aircraft, neither occupant is known to have suffered any injury. I would consider elevator detachment a "fail fatal" failure mode, so the two individuals are very lucky.

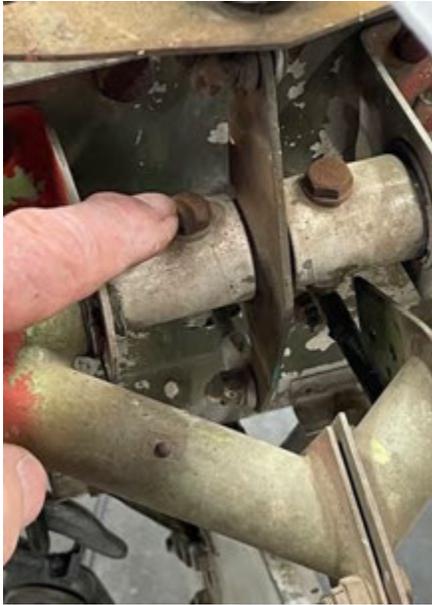
Photo: AA5 Torque Tube Bolts.jpeg

Both the Traveler and the Cheetah/Tiger utilize a torque tube bonded into the leading edge of the elevator. These left and right torque tubes are inserted into a central bellcrank. Each elevator's torque tube (L & R) is pinned to the bellcrank with a single bolt & nut. The bellcrank is rotated by cables connected to the control yoke in the cabin.

Photo caption: AA5 Elevator Torque Tubes & Bellcrank Assy.

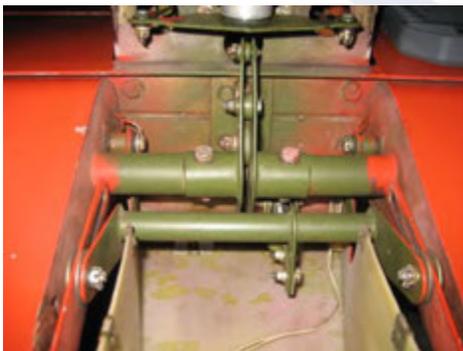
Photo: AA5A Torque Tube Bellcrank.jpg

Photo caption: AA5A Elevator Torque Tube & Bellcrank Assy.

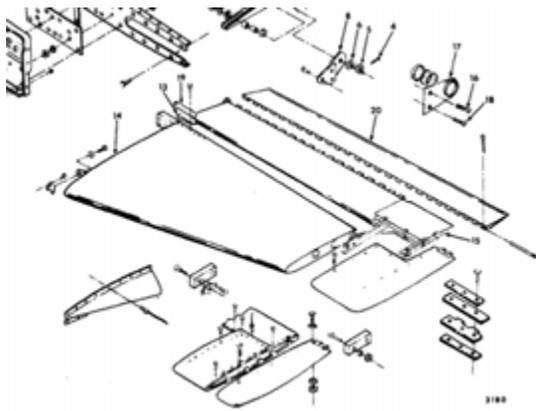
Photo: AA5 Fig 401.png

There are also differences in the method of attaching the elevators to the horizontal stabilizers. Each of the Traveler's elevators is secured by and pivots in a single outboard hinge. This hinge is attached on the outside rear of the outboard rib of the horizontal stabilizer, by two screws (AA-5, Fig. 401, items 17, 16 & 18.)

Photo Caption: AA5 IPC Fig 401 Elevator Assy

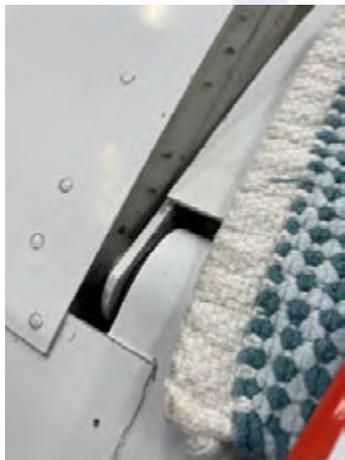
Photo: AA5 Outboard Hinge.jpeg

Photo caption: "Looking forward & outward. Blanket is laying on left horizontal stabilizer.

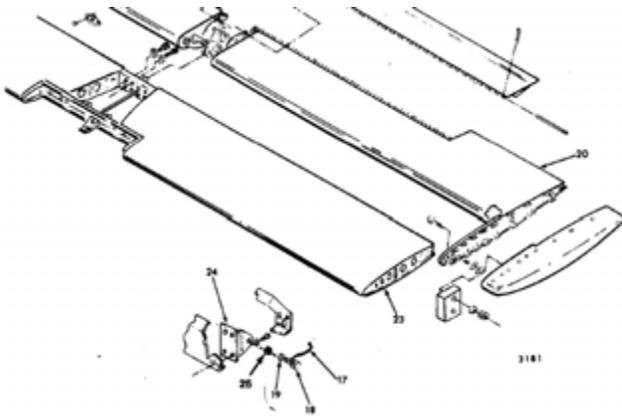
Photo: AA5A Fig 402.png

The Cheetah and Tiger's elevators each rotate on two bolts in two hinges, one located mid-span and one located at the outboard end. The mid-span and outboard hinges (item 24 in Fig. 402) are secured to the trailing edge of the horizontal stabilizer by four bolts. Illustration Fig. 402 only shows one of the hinges, in the detail view at the bottom of this illustration.

Photo Caption: AA5A IPC Fig 402 Elevator Assy

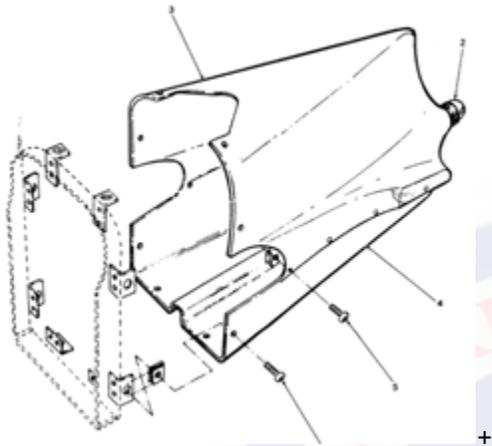
Photo: Tailcone IPC.jpg

Photo caption: AA5, AA5A & B Tailcone.

Removing the upper half of the tail cone will allow inspection of the torque tubes, bellcrank, bolts, and elevator trim system. It takes about 10 minutes to remove the fairing and 10 minutes to reinstall it. It requires a Phillips screwdriver. Steps: Trim control full aft (nose up.) Remove screws. Trim control full forward (nose down.) Remove upper fairing, being careful to not scratch the paint. Inspect. Reinstall upper fairing. Reinstall all screws loosely. All installed? Lightly torque all screws. Trim control back to neutral.
